Tropical Cyclone Nicole (AL162010)

Event Briefing

*Caribbean Risk Managers Ltd
Facility Supervisor*

8 October 2010

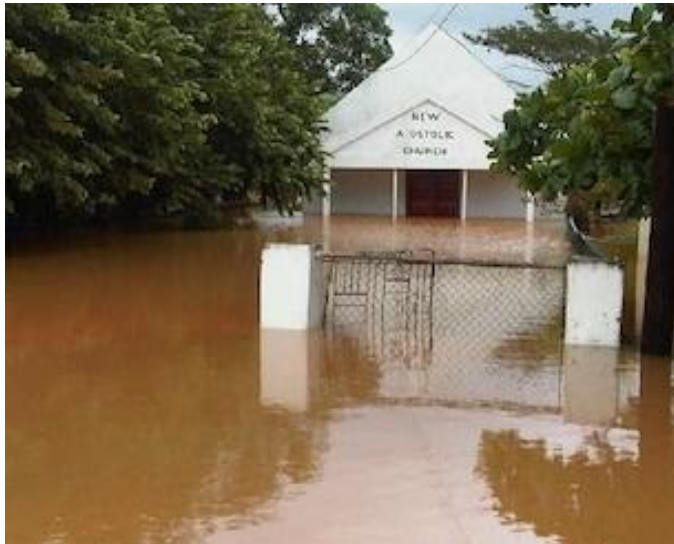
Figure 3

News reports indicate that as many as 13 people were killed and two people missing following the floods in Jamaica. A number of bridges and roads were destroyed or seriously damaged, although there were no reports of significant damage to commercial properties. Some residential areas however appear to have been flooded. The electricity supply was disrupted due to downed trees and poles and the Jamaica Public Service Company (JPS) had to activate its emergency operations centres across the island in order to restore power to some 170,000 customers in affected areas.

Photographs illustrating various aspects of damage are provided overleaf in Figures 3 to 6.
